ALL SAINTS CHURCH, MAIDSTONE

QUINQUENNIAL INSPECTION REPORT

16 March 2017 & 23 August 2017

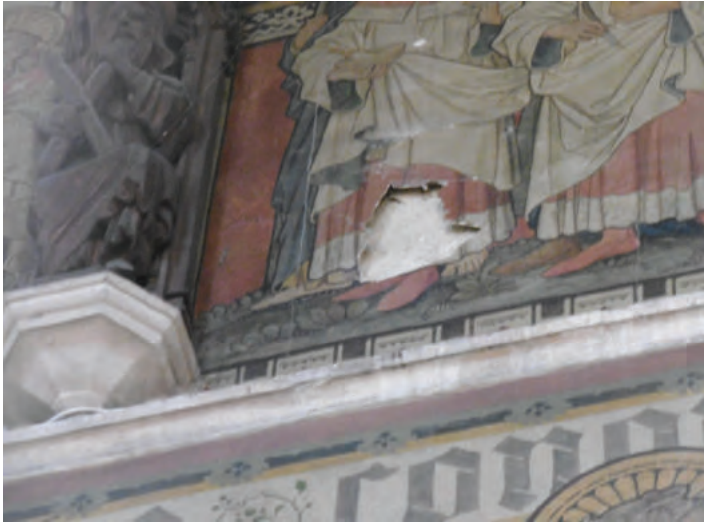
DETERIORATION OF THE WALL PAINTINGS

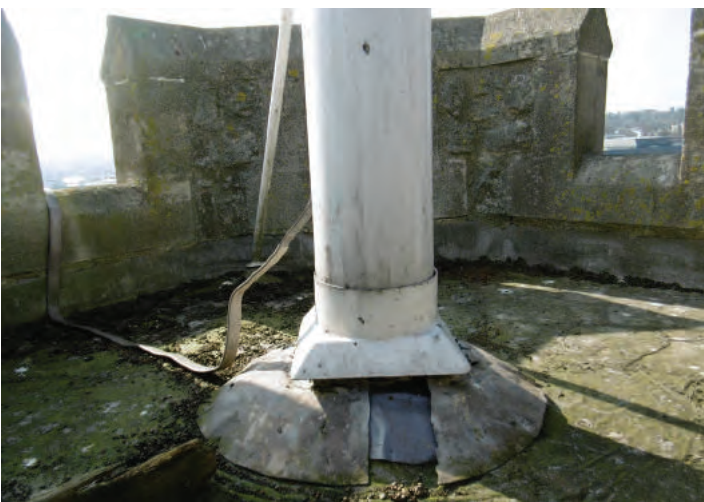
3.1.9 The weathering of the flagpole to the turret roof is defective and leaks, allowing water into the staircase interior. The detail needs improvement.

THE BASE OF THE FLAGPOLE

Priority A: Improve weathering to flagpole and repair flagpole base (in hand).

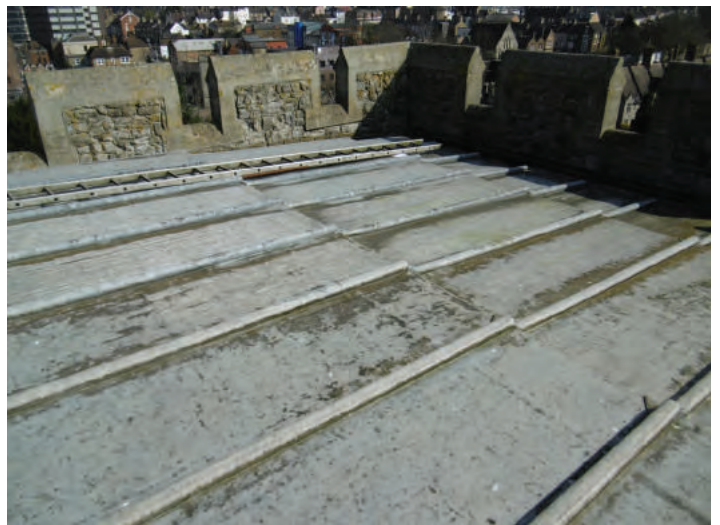
3.1.1 The tower roof is covered in lead with wood roll seams and drips at the joints. Generally, the lead is in fair condition. In the past minor cracks have developed in the roof around the joints, the repairs to these cracks are holding, no further works required at present.

THE TOWER ROOF

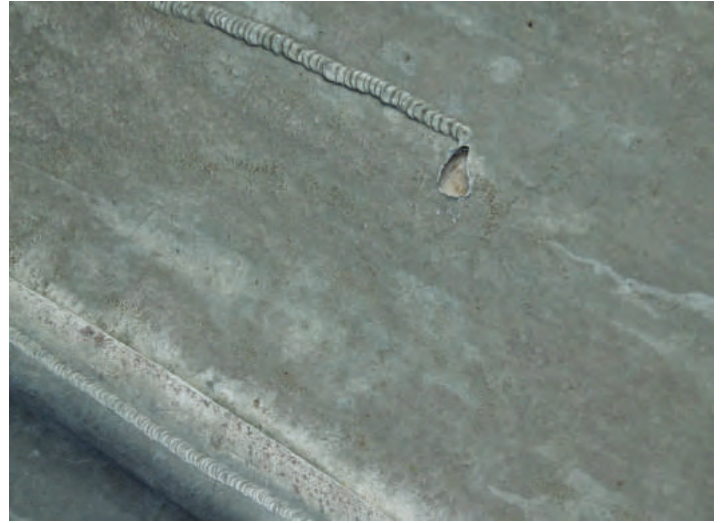
There are a number of new splits, corrosion holes and tears in the lead. These need to be patched to keep water out of the structure as a maintenance item, to assist the roof to survive until the complete re-leading can be undertaken.

THE LEAD CORROSION ON THE NAVE ROOF

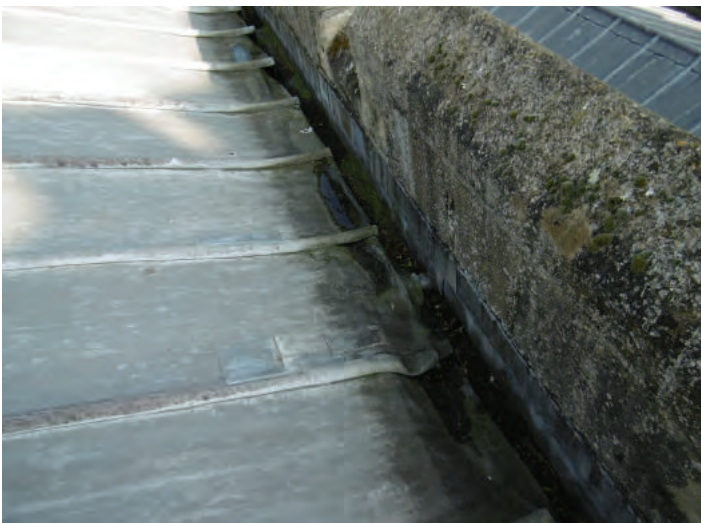
Slippage of the lead on the nave roof has been severe, particularly on the south slope. The lead has slipped up to 250mm. On the north slope the slippage is less severe but the ridge covering is under considerable stress. The lead sheets have deteriorated too far for patching to be considered as a repair option. While the roof can be temporarily restrained, further slippage will inevitably occur. Re-leading of this roof is needed. Patches in the roof covering have been repaired with self-adhesive strips, these are holding at present, but may need further attention during the quinquennial period.

LEAD CREEP ON THE NAVE ROOF

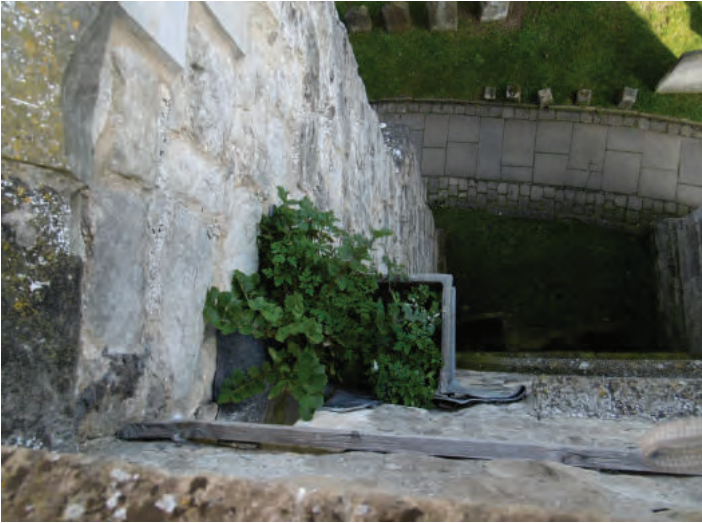
BLOCKED DOWNPIPE TO THE SOUTH AISLE

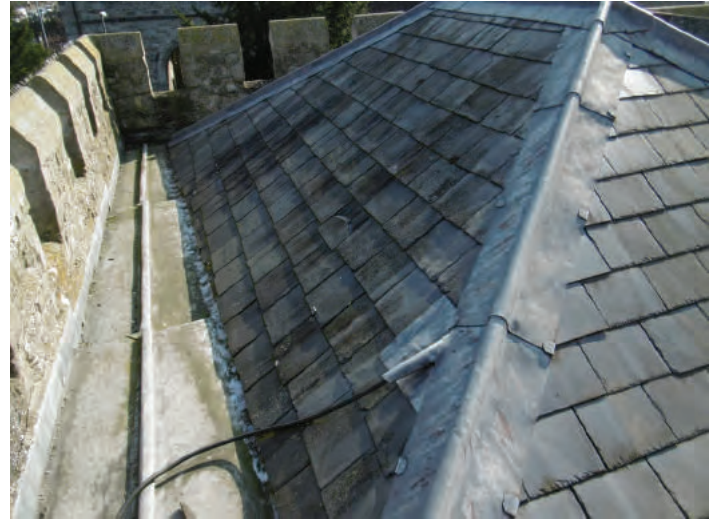
- 4.6.1 The vestry roof has a pitched slate roof with lead hips and lead parapet gutters around the perimeter of the roof.
- 4.6.2 The north slope of this roof was re-laid in 2006, the remaining sections of the roof are approximately 75 years old.
- 4.6.3 Generally the slate covering is in reasonable condition, there are a number of clipped slates in the older sections of the roof but these seem secure. A number of the slates are vulnerable to delamination and this roof will need to be checked annually for breakages. One slate is broken.

THE VESTRY ROOF

Priority A: Replace defective slate - £125.

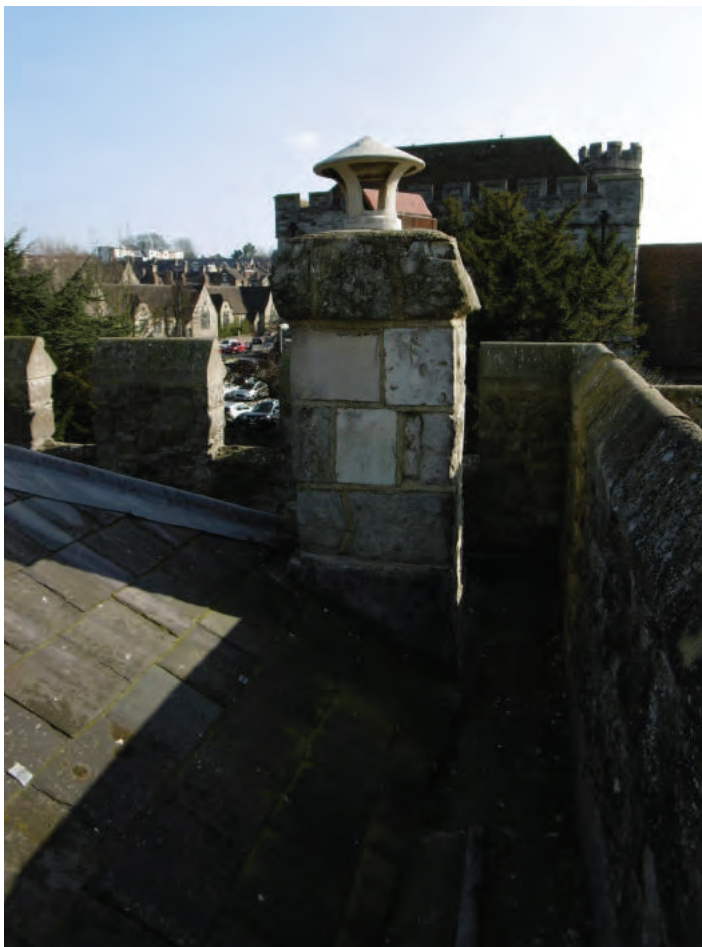
THE BOILER HOUSE CHIMNEY

Priority C: Replace capping stones to boiler flue - £3,700.

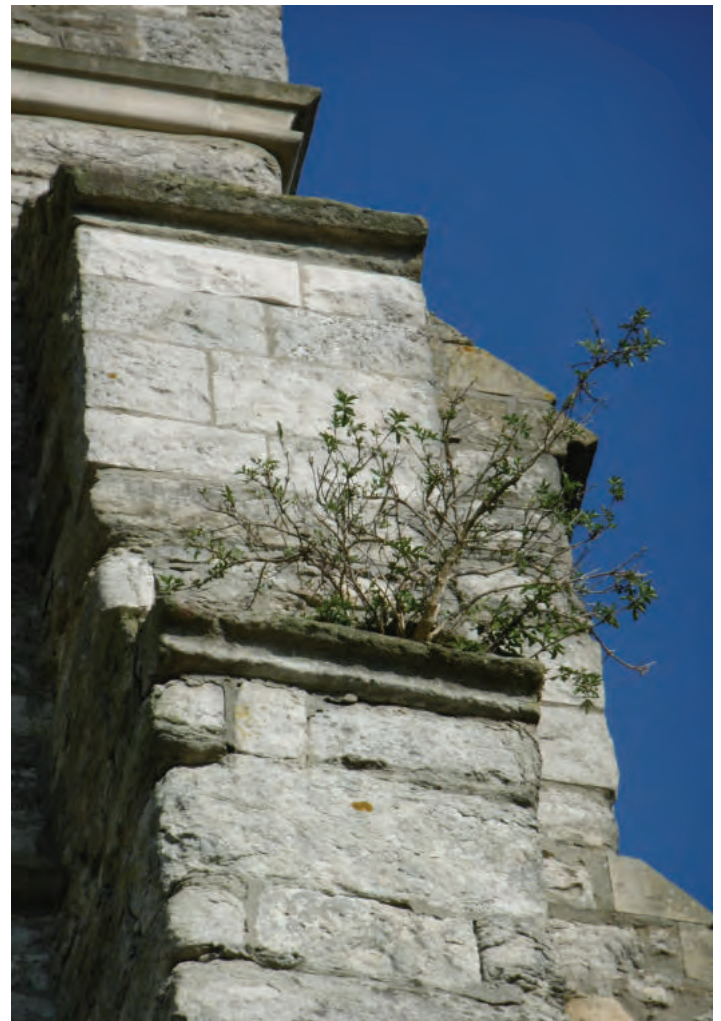
- 3.2.10 The vegetation growing in the south-western buttress has now damaged the weatherings and 2 weatherings appear to be fractured. Replacement of these weatherings will involve scaffolding and should be combined with other high-level works. It may be possible that the steeplejack (in removing the vegetation) will be able to stabilise the existing weathering until the replacement of the stones can be undertaken.

VEGETATION GROWTH ON THE TOWER

Priority C/D: Replace defective weatherings to south west buttress.

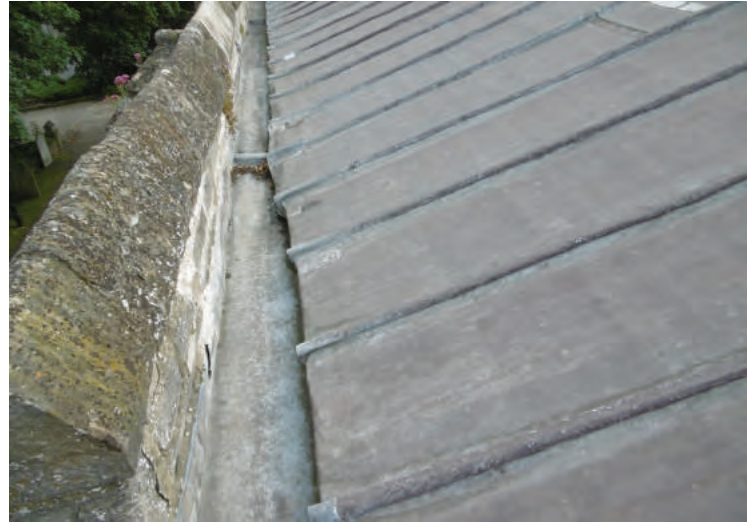
LEAD CREEP ON THE NORTH AISLE ROOF

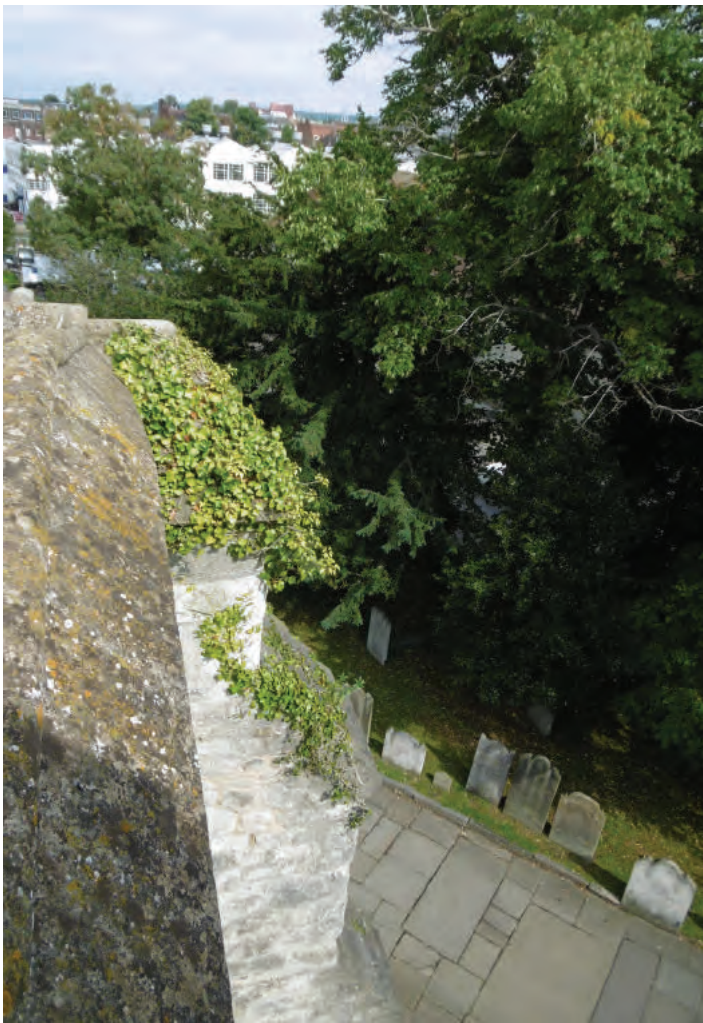
PLANT GROWTH ON THE EAST GABLE

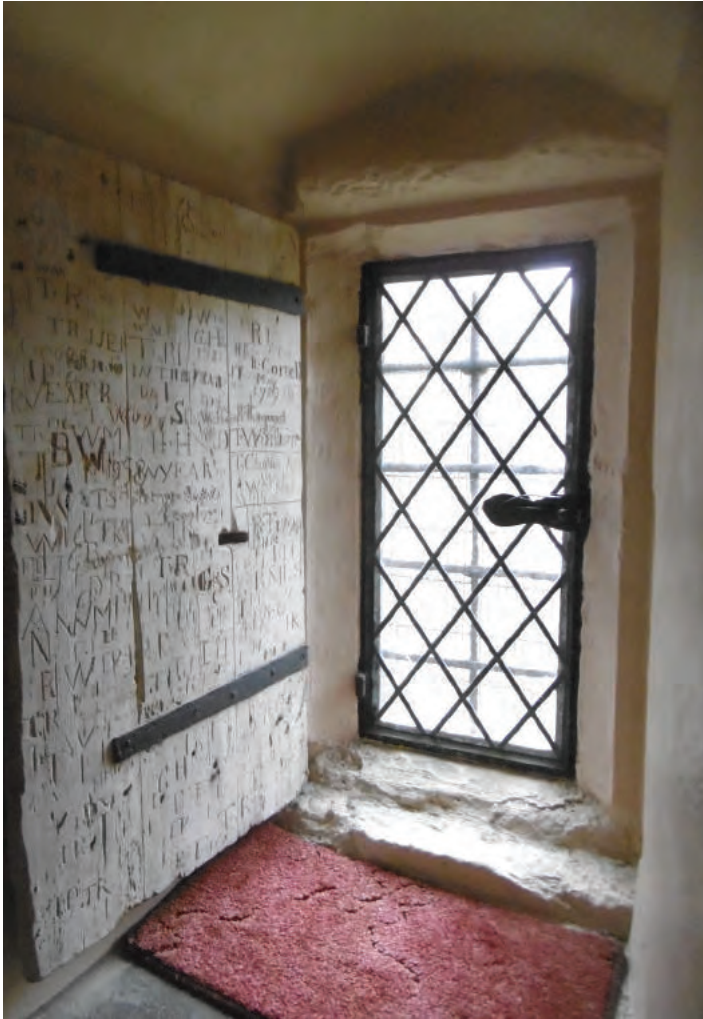
- 3.5.8 There are three window openings in the chamber. The west window is a fixed leaded light.
The south and east windows have opening casements glazed with leaded lights. There are internal shutters to all window openings.
The windows are in good condition and good decorative condition. The glass to the east window has 3 cracked panes.

THE RINGING CHAMBER WINDOW

Priority D: Repair ringing chamber windows.
