ALL SAINTS CHURCH, MAIDSTONE

QUINQUENNIAL INSPECTION REPORT

21st & 28th June 2022

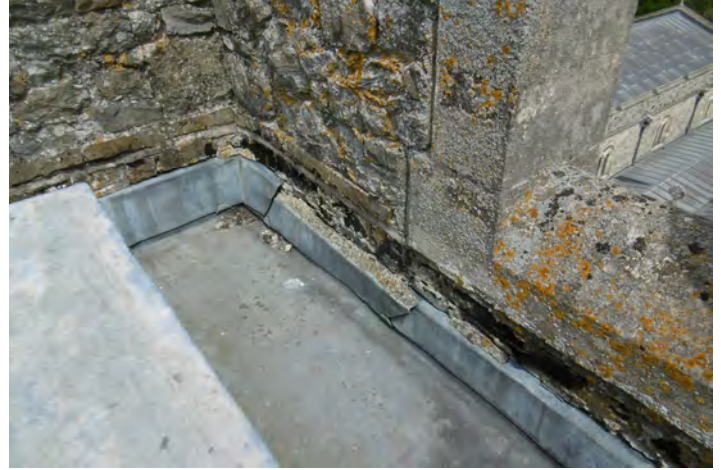
3.1.3 There has been failure to the pointing to the abutment flashings on the north, east and south parapet walls and the east wall. Repairs are required.

DECAY OF THE TOWER ROOF ABUTMENT FLASHINGS

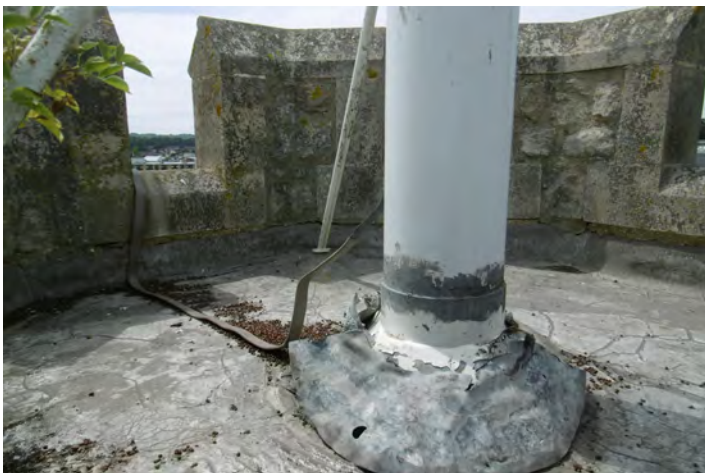
3.1.9 The weathering of the flagpole to the turret roof is defective and leaks, allowing water into the staircase interior. The detail needs improvement.

THE FLAGPOLE WEATHERING

Priority A: Improve weathering to flagpole and repair flagpole base – cost not determined.

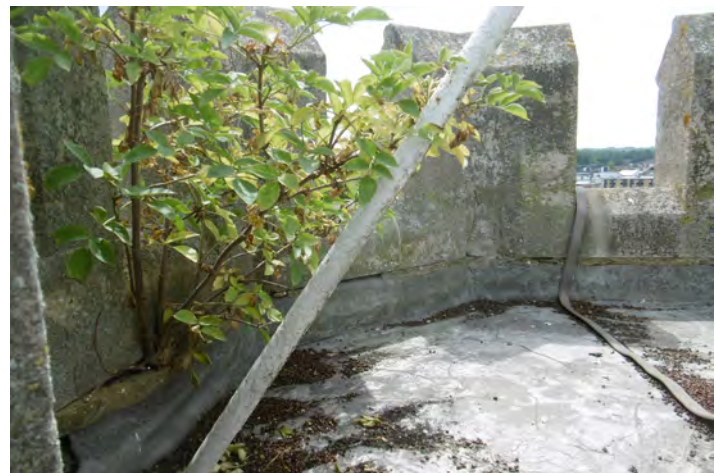
VEGETATION GROWTH ON THE TOWER TURRET ROOF

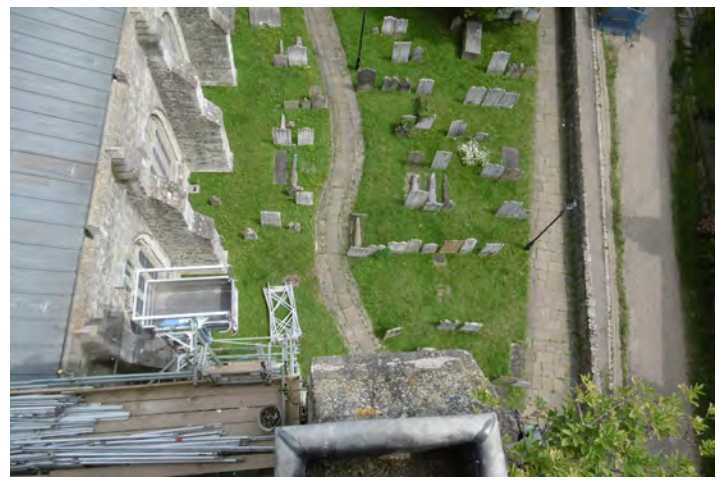
- 3.2.9 There is some vegetation growth in the upper weatherings in the west side buttress at the south west corner of the tower and at the head of the downpipe on the south-east side. These shrubs were noted at the last three quinquennial inspections and have increased in size.

Around the third weathering there is no vegetation growth, but cracks are apparent in the core of the buttress. Two of the weatherings appear to have moved. Investigation and repair is required.

VEGETATION GROWTH IN THE TOWER BUTTRESSES

Priority A: Repair tower buttress weatherings - £10,000.

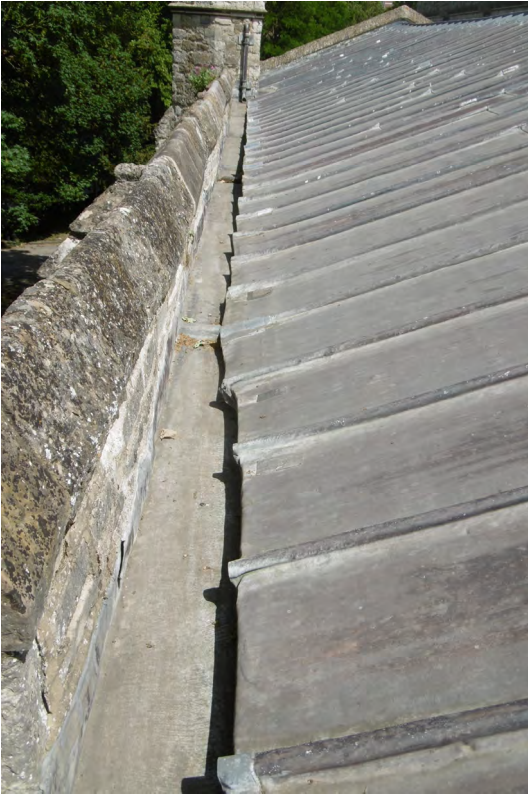
LEAD SLIPPAGE ON THE NORTH SLOPE OF THE NORTH AISLE

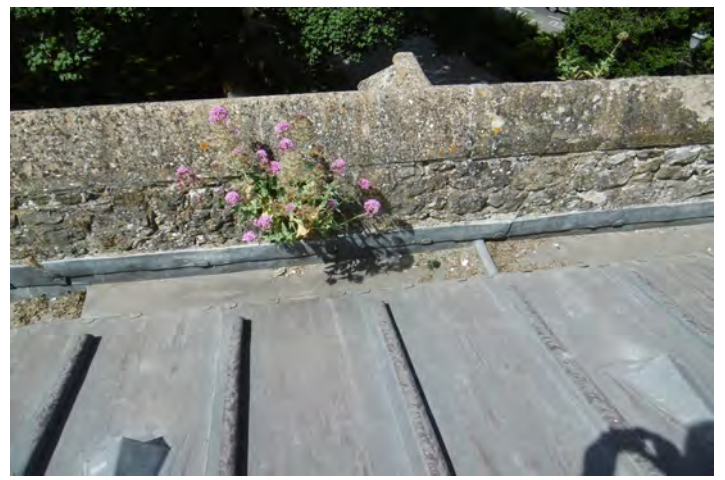
VEGETATION GROWTH IN THE NORTH AISLE PARAPET

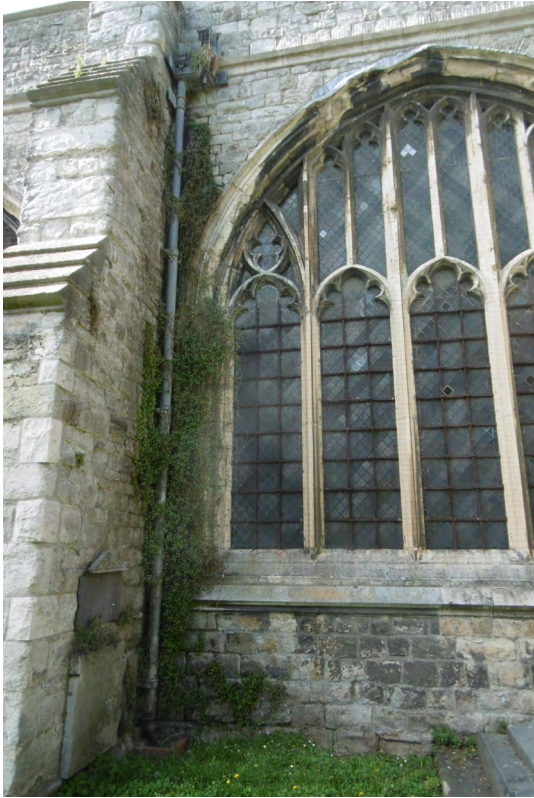
VEGETATION GROWTH ON THE SOUTH ELEVATION OF THE ORGAN LOFT

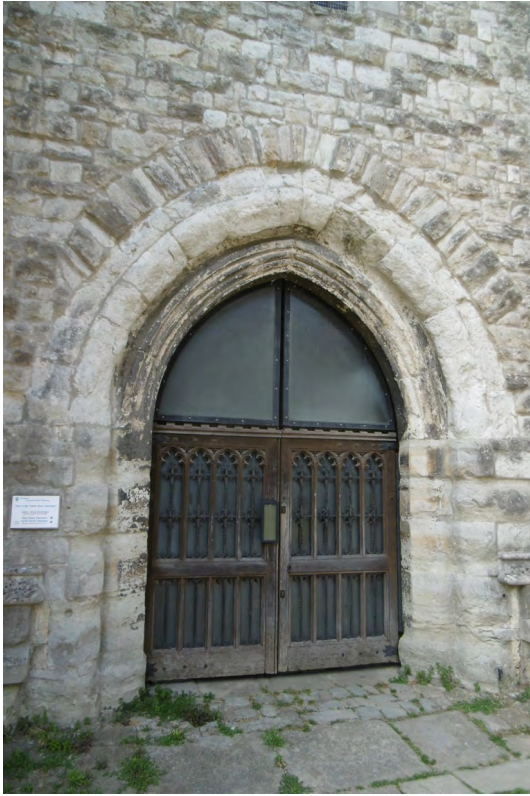
THE SOUTHTOWER DOOR

- 3.2.12 The relieving arch of the south door opening is formed of ragstone. This is heavily weathered and the surface continues to delaminate. Removal of the loose material would slow down the rate of decay of the core work. In the long term, it will be necessary to replace the hood mould that has completely eroded away but this should be seen as a long-term ambition.

Priority B: Remove loose material from south door arch - £300.

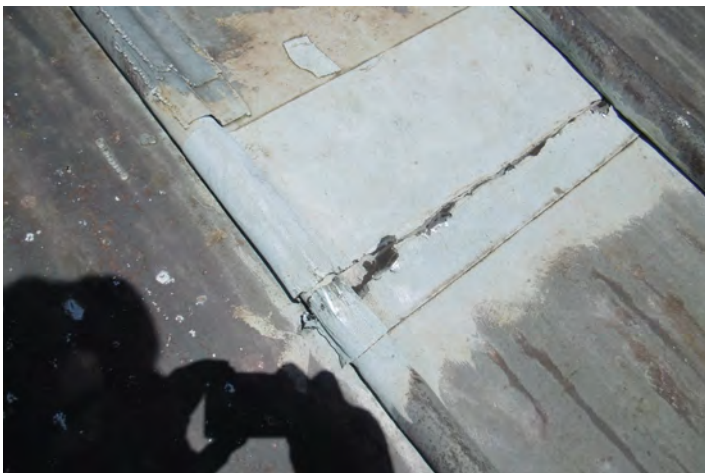
- 4.3.2 The eastern nave roof is covered with lead with hollow roll seams and lapped joints. Slippage of the lead on the nave roof has been severe, particularly on the south slope. The lead has slipped up to 250mm. On the north slope the slippage is less severe but the ridge covering is under considerable stress. The lead sheets have deteriorated too far for patching to be considered as a repair option. While the roof can be temporarily restrained, further slippage will inevitably occur. Re-leading of this

roof is needed. Patches in the roof covering have been repaired with self-adhesive strips, additional patches have recently been added as an emergency measure. These are holding at present but may need further attention during the quinquennial period.

There are a number of new splits, corrosion holes and tears in the lead since the last inspection. These need to be patched to keep water out of the structure as a maintenance item, to assist the roof to survive until the complete re-leading can be undertaken.

LEAD SLIPPAGE ON THE EASTERN NAVE ROOF

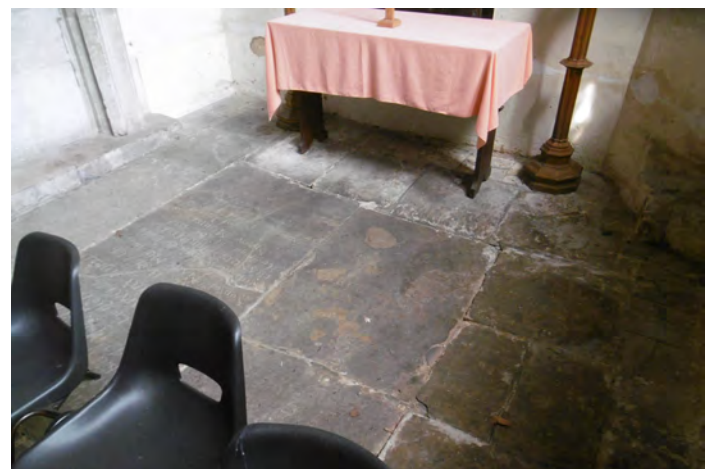
SETTLEMENT IN THE SOUTH CHANCEL AISLE
