ALL SAINTS CHURCH, MAIDSTONE  
QUINQUENNIAL INSPECTION REPORT  
Diocese of Canterbury

13 September 2012

Simon Marks, RIBA AABC

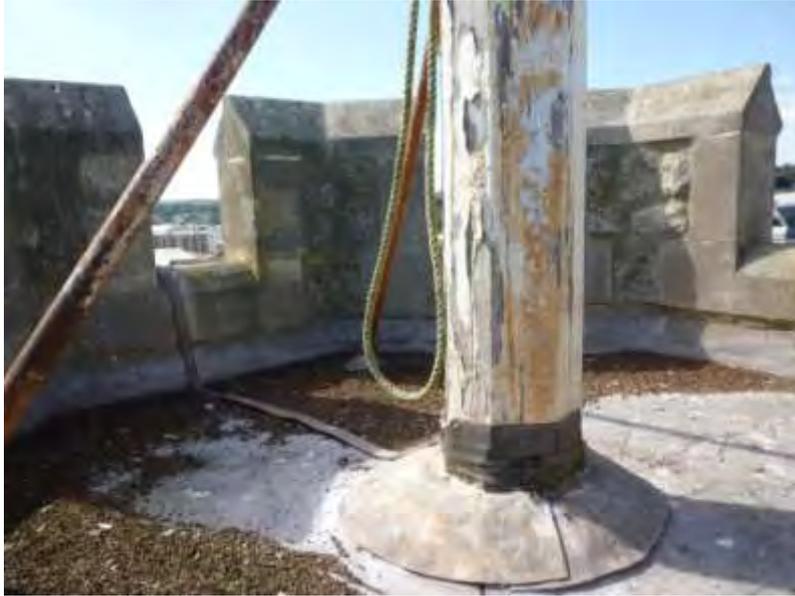
3.1.9 The weathering of the flagpole to the turret roof is defective and leaks, allowing water into the staircase interior. The leak is effecting the York stone capping of the turret. Rusting of the steel stays to the base of the flagpole is advanced. The weathering should be improved and the steel braces to the base of the flagpole upgraded. This work is in hand.

Flagpole turret roof

Priority A: Improve weathering to flagpole and repair flagpole base (in hand)

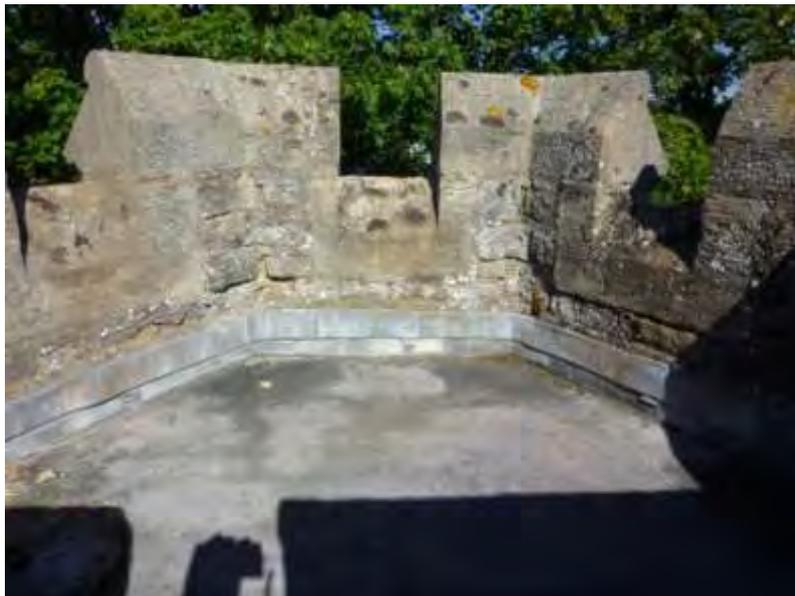
North aisle access turret roof

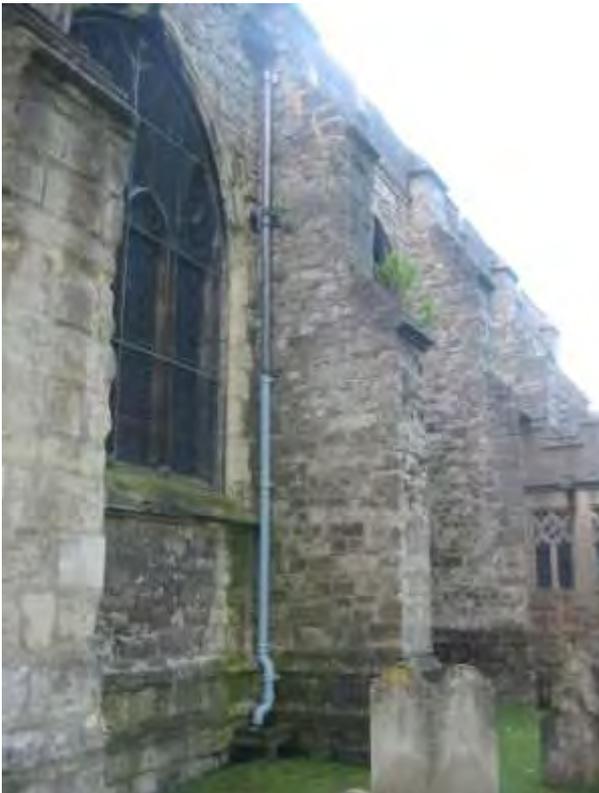
Stone work to the Nave North Aisle

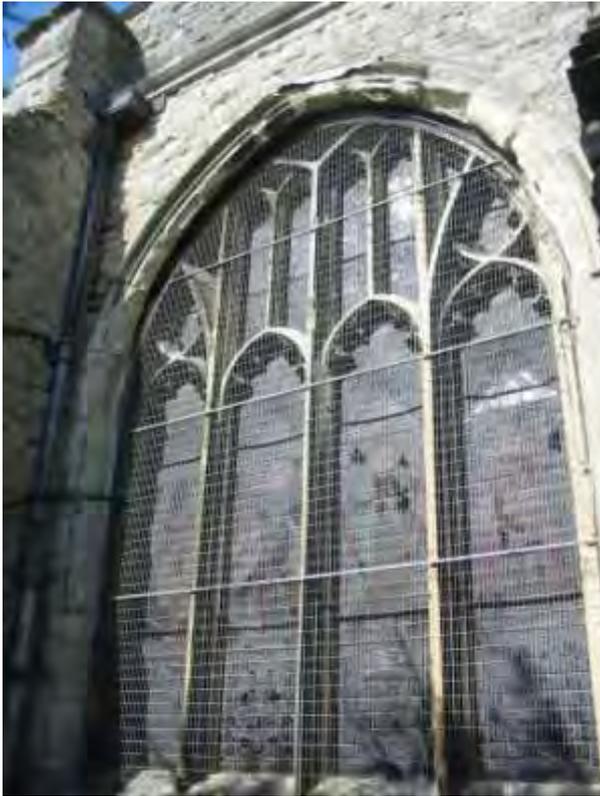
Vousoir decay to the Nave South Aisle Window

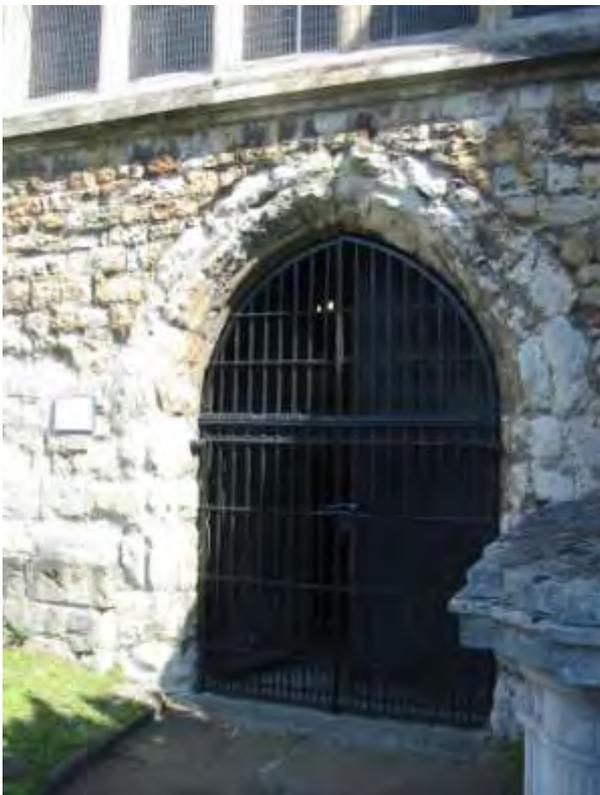
Stone deterioration around the West Gable door

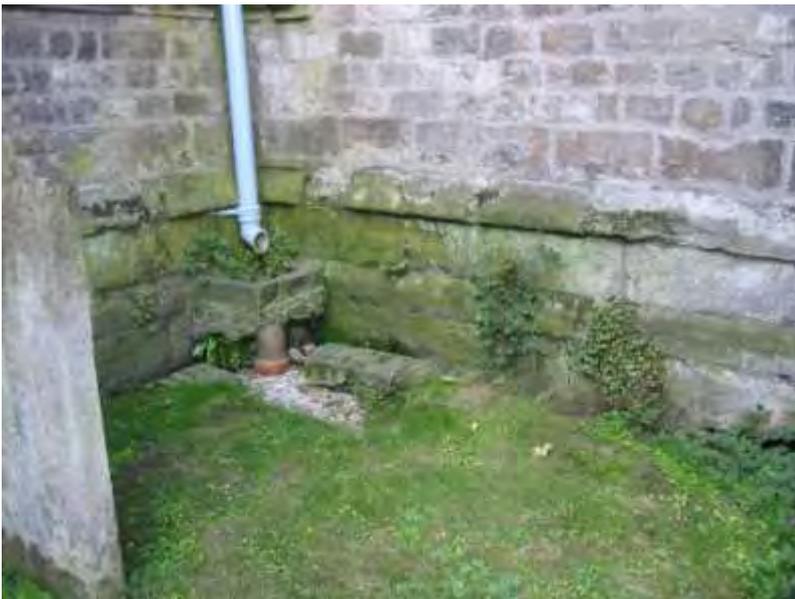
Defective gully and drainage to the East end of the Nave North Aisle

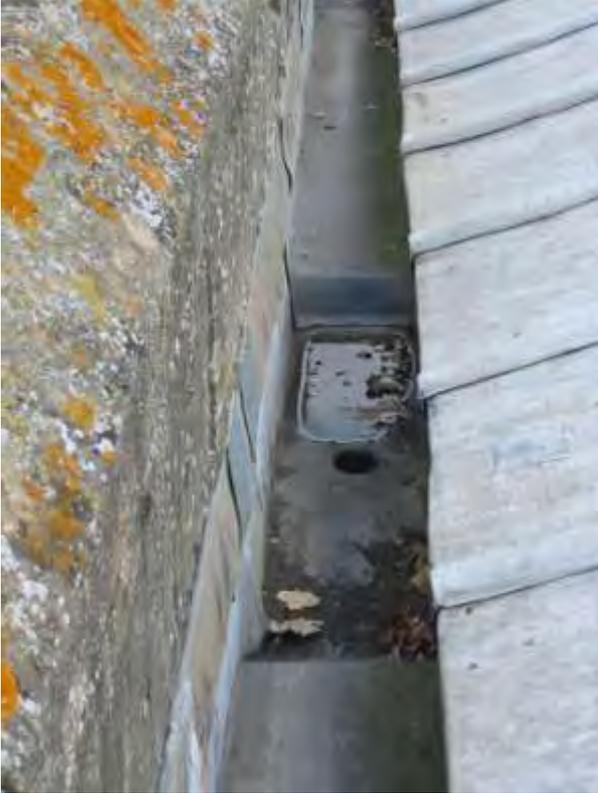
- 4.3.2 Although the parapet gutter bays are of a reasonable length they are known to have leaked in the past and decay has occurred in the wall plates. There is active beetle infestation in the wall plate areas. It is thought that timber decay has been triggered by the overflow of the sumps. In a number of places the sole boards to the gutters have rotted away, leaving the lead inadequately supported.

Ponding caused by decaying gutter supports on the Nave roof

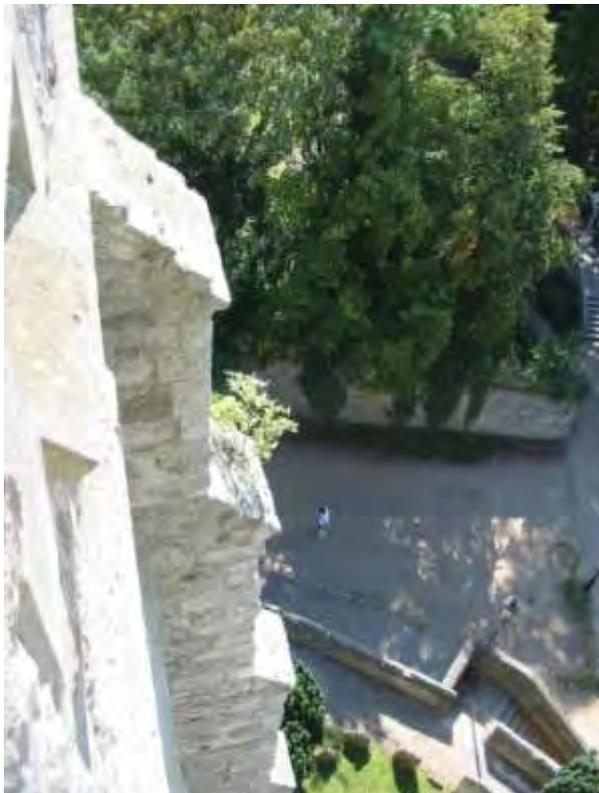
- 3.2.10 The vegetation growing in the south western buttress has now damaged the weatherings and 2 weatherings appear to be fractured. Replacement of these weatherings will involve scaffolding and should be combined with other high level works. It may be possible that the steeplejack (in removing the vegetation) will be able to stabilise the existing weathering until the replacement of the stones can be undertaken.

Vegetation growth in the Tower Buttress

Priority C/D: Replace defective weatherings to south west buttress

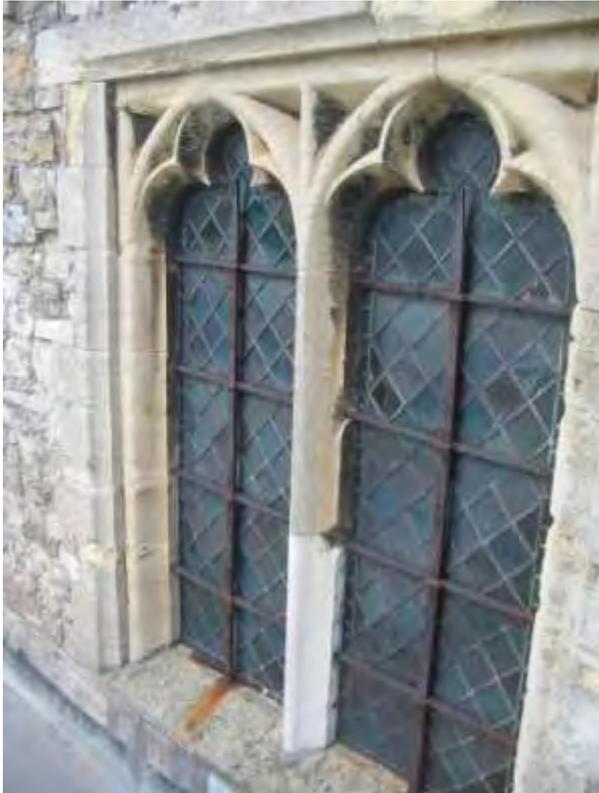
Rusting Ferramenta to South Nave Clerestory

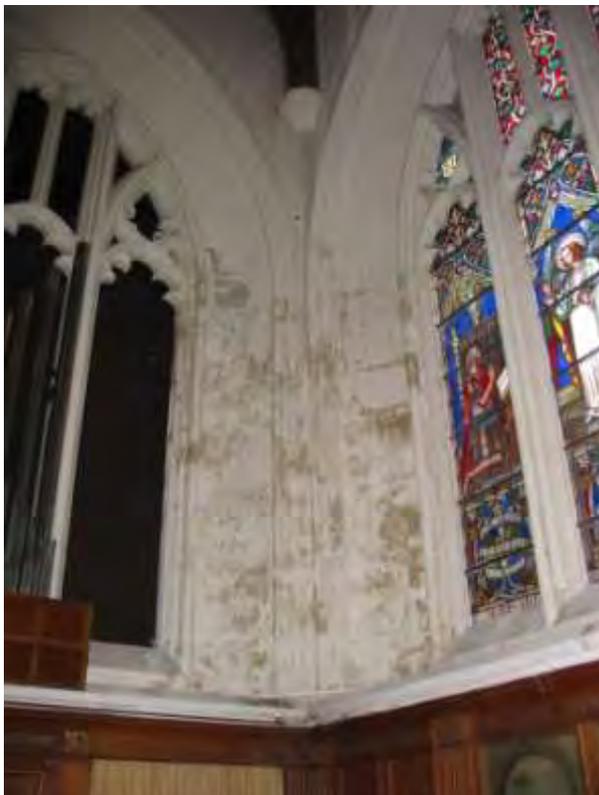
Water damage to the walls – South East corner of the nave south aisle

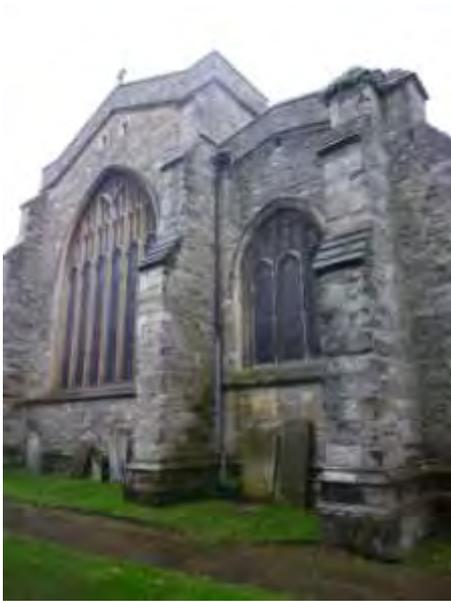
Blocked hopper at east gable of north aisle

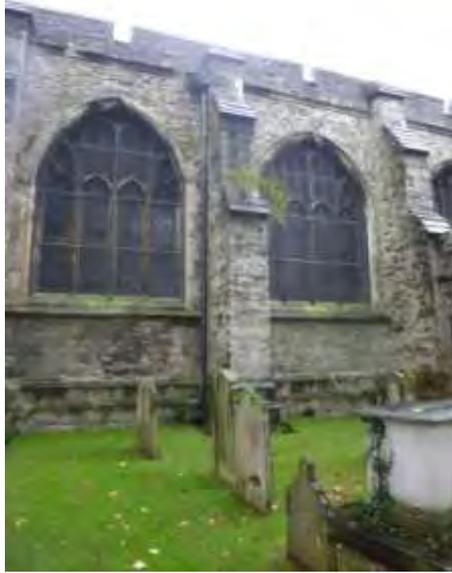
Vegetation growth in the north nave aisle

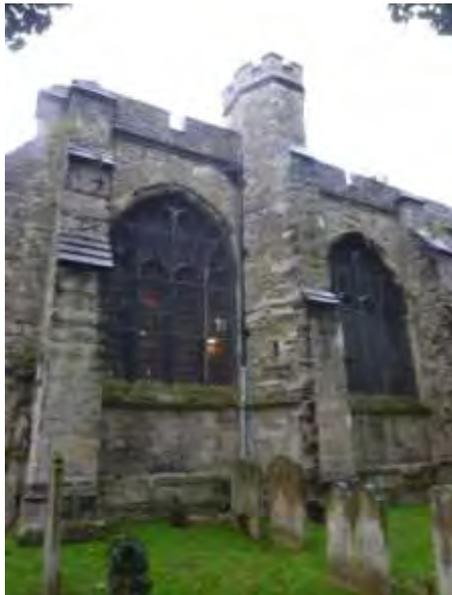
Stone decay in the north aisle access turret
