CONFIRMATION OF DAC ADVICE MAIDSTONE, ALL SAINTS – NAVE FLOOR REPAIRS

Statement of Need for the Main Nave Floor in All Saints Church, Maidstone

All Saints Church, Maidstone - Floors
Repairs to the Floor

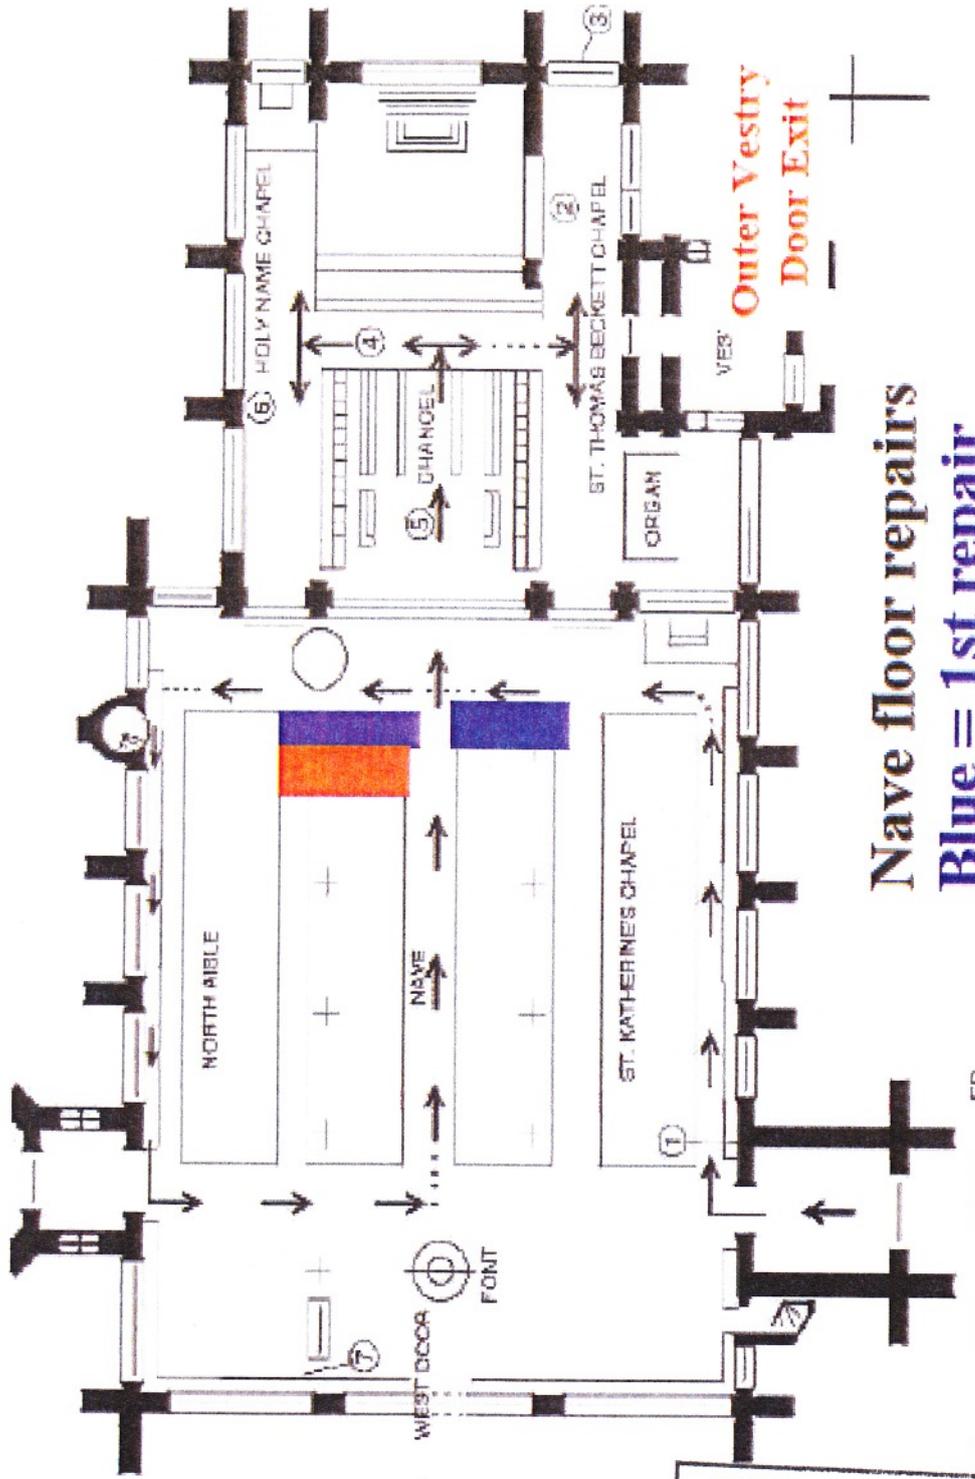
- 1) In 2010 the floor boarding and joints on the east end of the north side of the nave marked mauve on the plan were replaced following decay, which resulted in the organ console falling through the floor boards. The decaying floor boards are noted in the Quinquennial report and the architect notes this needs to be addressed. The floor boarding was then stained to match the floor boarding (blue on the plan) on the east end of the south side. There were no pews on this area. The PCC request a confirmatory faculty for this area's floor boarding to be replaced and stained.

- 3) The floor adjacent (westward) to this east on the north side floor area (red on the plan) then showed some visible signs of decay (holes) and felt spongy underfoot. It was decided that this area also needed to be replaced and undertook its replacement when the works nearing completion were halted and the court hearing took place. The PCC would like a confirmatory faculty for the works that have been done and further permission for the works to be completed and the wood stained to match the earlier work.

Nave floor repairs
Blue = 1st repair
Mauve = 2nd repair
Red = 3rd repair
